Original Article

Fracture Resistance and Surface Roughness of Zirconia Crowns Veneered by Layering, Press-on, and CAD-on Methods

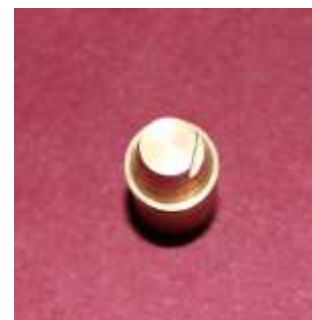
Figure 1: Brass metallic die

The Institutional Review Board (IRB) approval was obtained for this experimental *in vitro* study (IR.SUMS.REC.1398.376). In this study, 30 brass dies were milled with a CNC machine (CNC350; Arix Co. Tainan Hsin Taiwan) in standard size for all-ceramic crowns with 6° occlusal convergence, 1 mm wide shoulder finish line, and axial anti-rotational design to ensure identical seating of the copings on the die (Figure 1) [23].

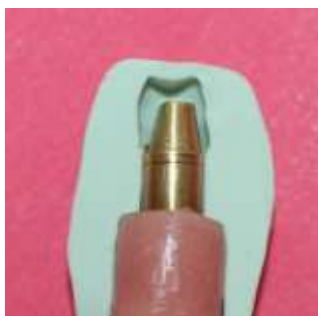
Figure 2: The putty index to ensure that the dimensions of all specimens are identical

a uniform thickness of 0.5mm around and 30µm spacer, 1mm from margin. The copings were designed 20% larger to compensate for polymerization shrinkage [10]. The zirconia copings were fabricated in a milling machine (Inlab MC XL, Dentsply Sirona, USA) from pre-sintered zirconia blocks (IPS e.maxZir CAD, Ivoclar Vivadent, Schaan, Liechtenstein), and sintered in the synthesis furnace at 1580°C (Programat S1, Ivoclar Vivadent, Germany). The specimens were divided into three groups (n=10) and veneered with porcelain by layering, press-on, and CAD-on methods. For layering method, porcelain powder was mixed with the specific liquid to make the veneers through layering method. The obtained paste was applied over the copings with a brush in several steps. This technique consisted of four sintering stages: 1) the liner (IPS e.max, Zirliner; Ivoclar Vivadent AG, Germany), which was fired in a 960°C furnace, 2) the first layer of dentin and enamel, which was a nano-fluoro-apatite-glass-ceramic (IPS e.max Ceram; Ivoclar Vivadent AG, Schaan, Liechtenstein) processed at 750°C, 3) the second layer of dentin and enamel, and 4) the glaze [24]. A single skilled technician did the veneering of all the copings. The thickness of the veneering material was 0.7mm at the margin and a maximum of 1.5mm on the occlusal surface. The restorations were formed slightly larger to compensate for polymerization shrinkage. A putty index was prepared and used to ensure that the dimensions were identical for all specimens (Figure 2).

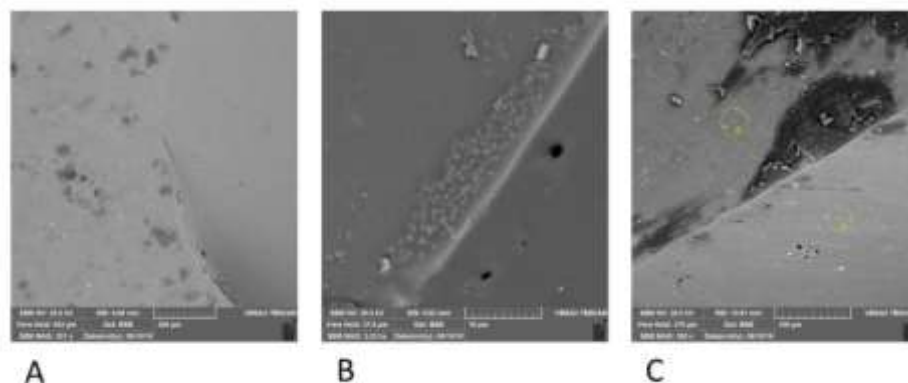
Figure 5: Electron microscope scans (SEM, TESCAN Vega3, Czech Republic) at 200× to 500× magnification of the fractured samples. **a:** Adhesive failure pattern, **b:** Cohesive failure pattern, **c:** Mixed failure pattern

the Instron testing machine (Zwick/Roell, Z020, Germany), a vertical force was applied to the occlusal central fossa at a crosshead speed of 0.5mm/min until fracture occurred. To assess the failure pattern (adhesive/cohesive), specimens were cleaned with alcohol and then examined with a scanning electron microscope (SEM, TESCAN Vega3, Czech Republic) at 200× to 500× magnification (Figure 5). An adhesive failure pattern was present when the failure occurred at the interface between the coping and veneer, exposing the zirconia coping; a cohesive failure pattern referred to the failure within the veneer, leaving a layer of the veneering ceramic on the zirconia coping. Finally, a mixed failure pattern was considered as a combination of adhesive and cohesive failure.

Adhesive: the failure occurred at the coping and veneer interface, exposing the zirconia coping; cohesive: the failures occurred within the veneer, identified with a layer of veneering ceramic remaining on the zirconia coping. Mixed: a combination of adhesive and cohesive failure. L: layering; P: Press-on; C: CAD-on;

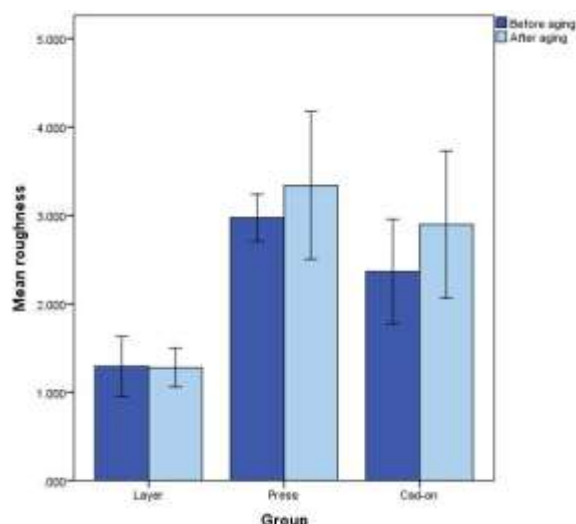
Figure 6: Mean surface roughness value (Ra) and 95% confidence interval among the three groups before and after aging

The mean surface roughness values of the three groups were significantly different before ($p < 0.001$) and after aging ($p < 0.046$). The pair-wise comparison showed that the mean surface roughness before aging was significantly lower in the layering group than in the

The present study also evaluated surface roughness of crowns before and after aging. In this study, press-on group exhibited higher surface roughness before and after aging, followed by the CAD-on and the layering groups. In addition, the layering technique was performed manually by an experienced technician, which resulted in lower surface roughness, as it highly relies on the dental technician's skills. The higher surface roughness resulting from press-on could be due to the
